Interaction between Science, Technology and Architecture in Timber Construction

The 6th century timber roof of St Catherine Sinai: identification, research and proposals for its protection

Petros Koufopoulos, Marina Myriantheos-Koufopoulou,
Costas Zambas, Amerimni Galanou, Ioanna Dogani

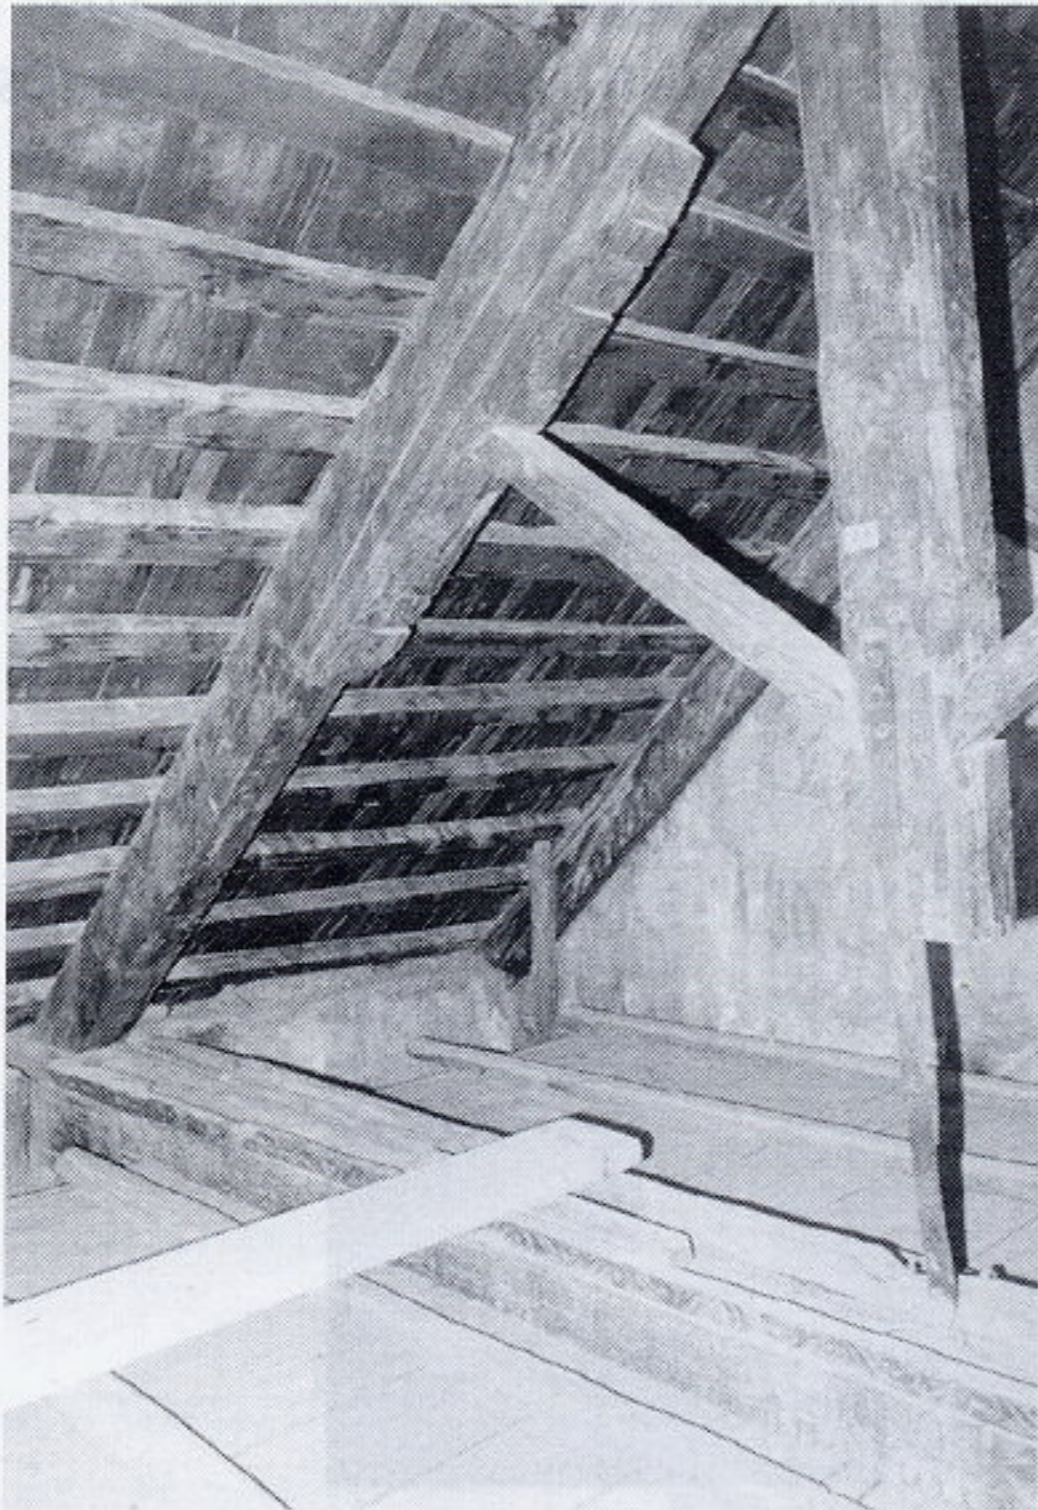
Figs. 4 and 5. Views of the interior of the roof of the central nave showing original trusses no. 2 and no. 9, purlins, decking and the ridge beam.
